Accessible Trailhead and Trail Loop

Outer Trailhead Concept

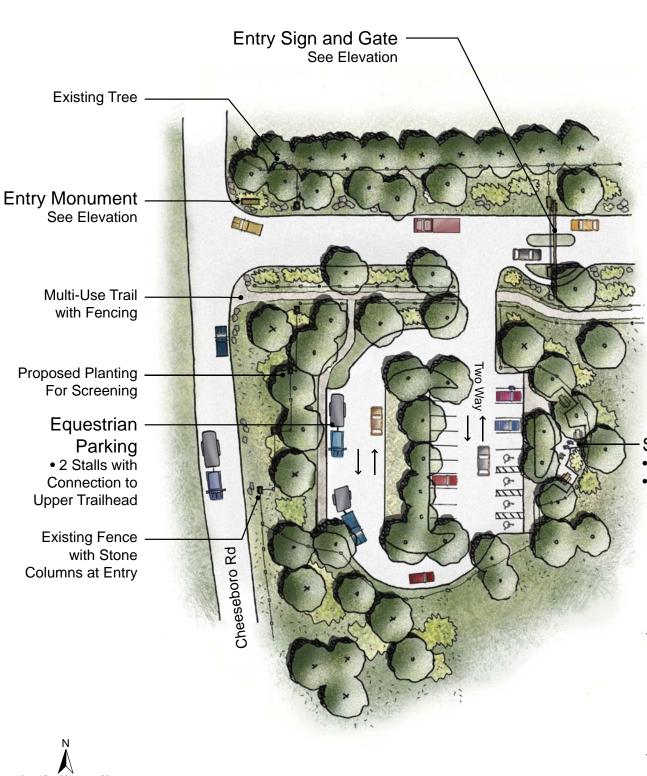
Shaded Picnic Area

- Picnic Tables
- Informational/Interpretive
 Signage

Proposed Parking Summary

- 15 Standard
- 4 Accessible
- 2 Equestrian
- 21 Total Spaces

Existing Parking

- 20 Standard
- 0 Accessible
- 0 Equestrian
- 20 Total Spaces

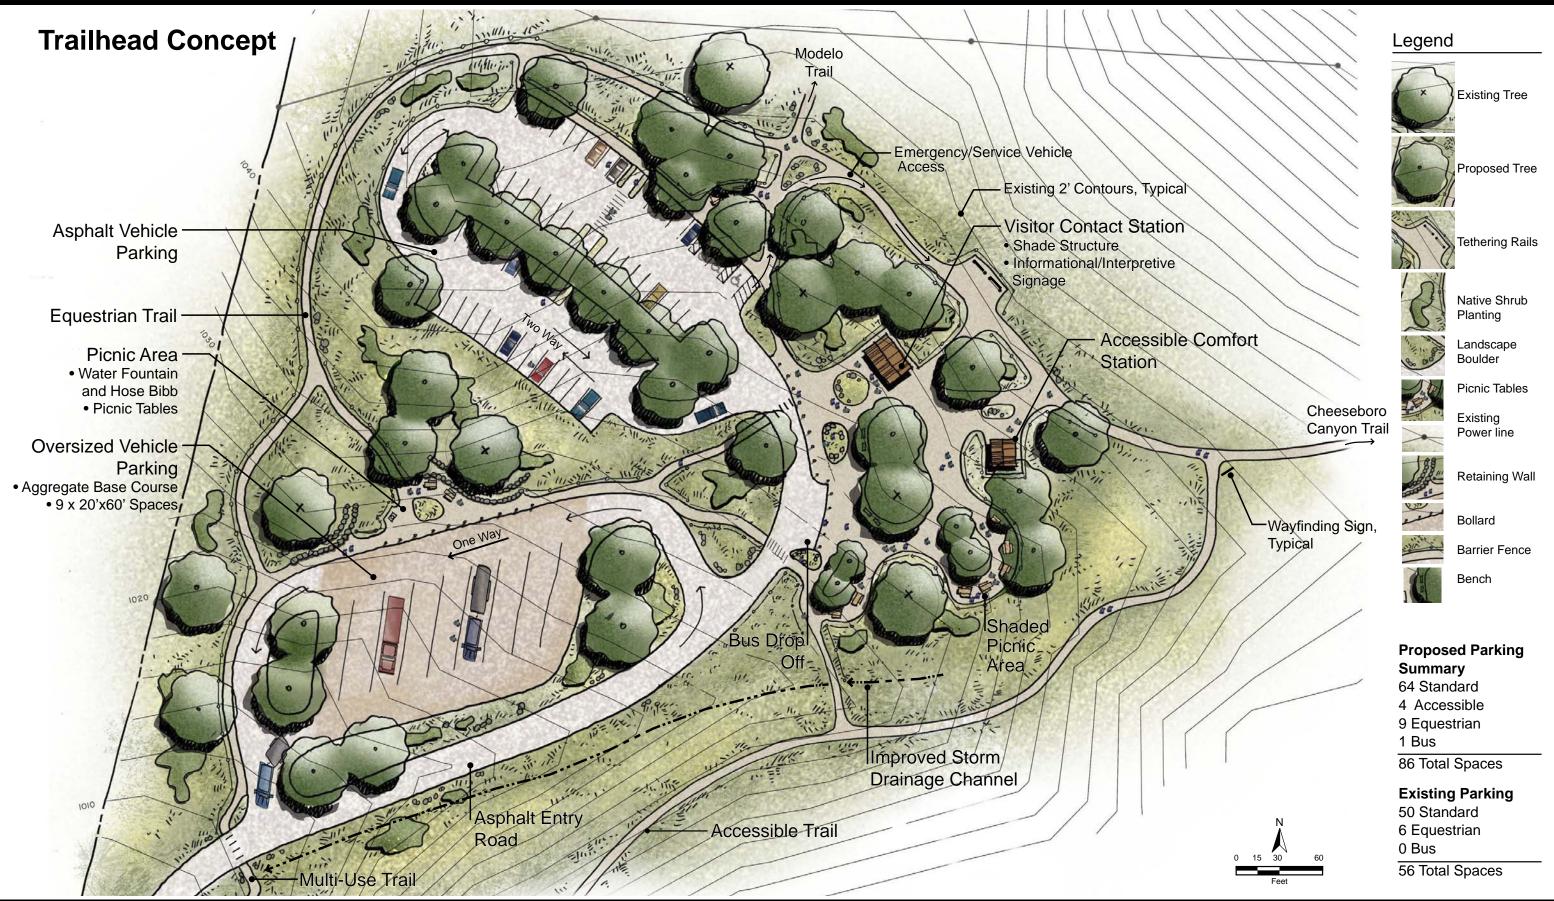
Typical Accessible Trail Spur Accessible Trail Landscape Boulder Accessible Path **Existing Vegetation Boulder Retaining Wal** Water Channel Interpretive Sign

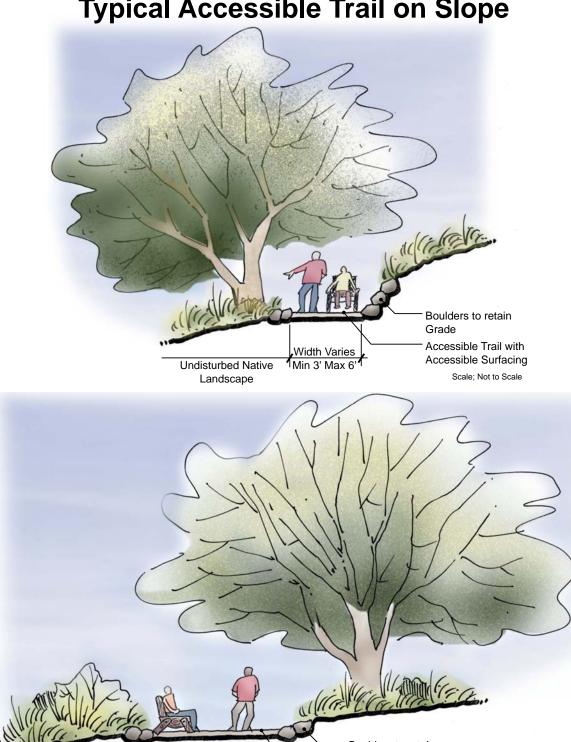
Typical Accessible Trail Rest Area

Undisturbed Native

Grade

Accessible Trail with
